Navajo Abandoned Uranium Mine

Site Screen Report

Deneh Nezz 1, 2 AUM Site

March 2010

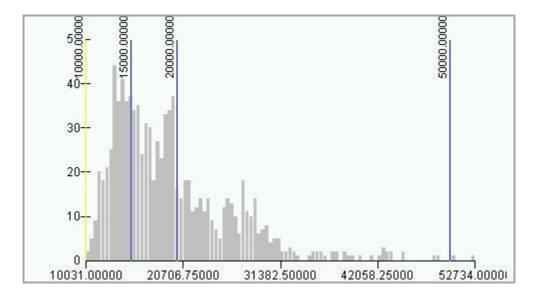
The following chart and statistics were generated by ESRI ArcGIS 9.3.1, and show the general distribution of the site gamma radiation measurements. The horizontal X axis represents the gamma radiation reading levels in cpm (lowest levels to the left). The vertical Y axis represents the frequency of each gamma radiation level.

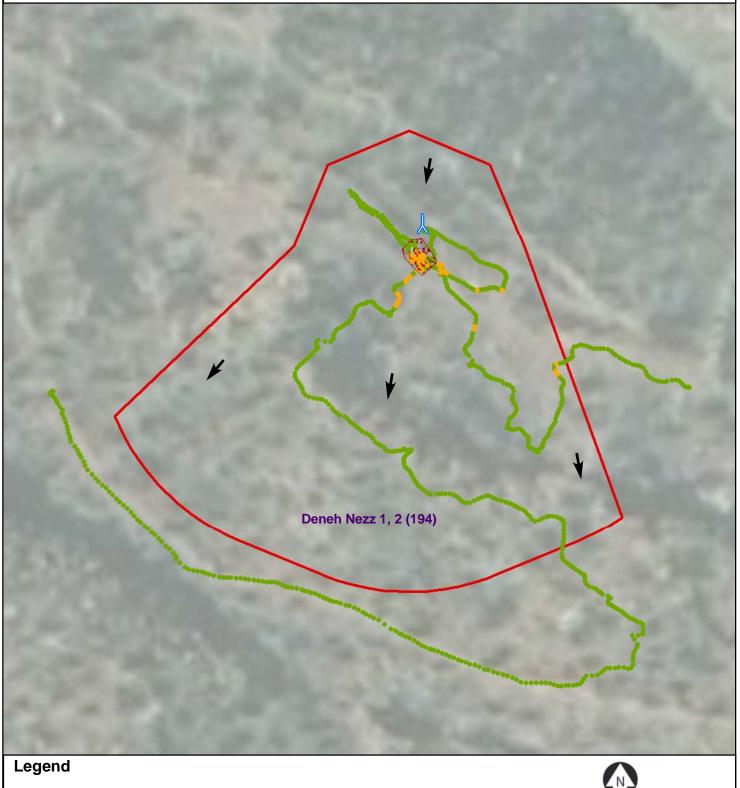
Figure 1 - Gamma Radiation Measurements, Above Two Times Background
Deneh Nezz 1,2 (194)
Sanostee Chapter, Navajo Nation, Arizona

A total of 957 gamma radiation measurements were collected from the mine site, ranging from 10,031 cpm to 52,734 cpm. Measurements in the vicinity of the waste debris were found at levels of approximately 45,000 cpm, and at approximately 21,000 cpm above the sealed adit. The measurements are represented in Figures 1 and 2.

Observed Waste Pile
